RSTUDY+  
REPLACEMENT RESERVE STUDY  
**FLINT HILL MANOR**  
Homeowners Association

Oakton, Virginia

**November 2003**

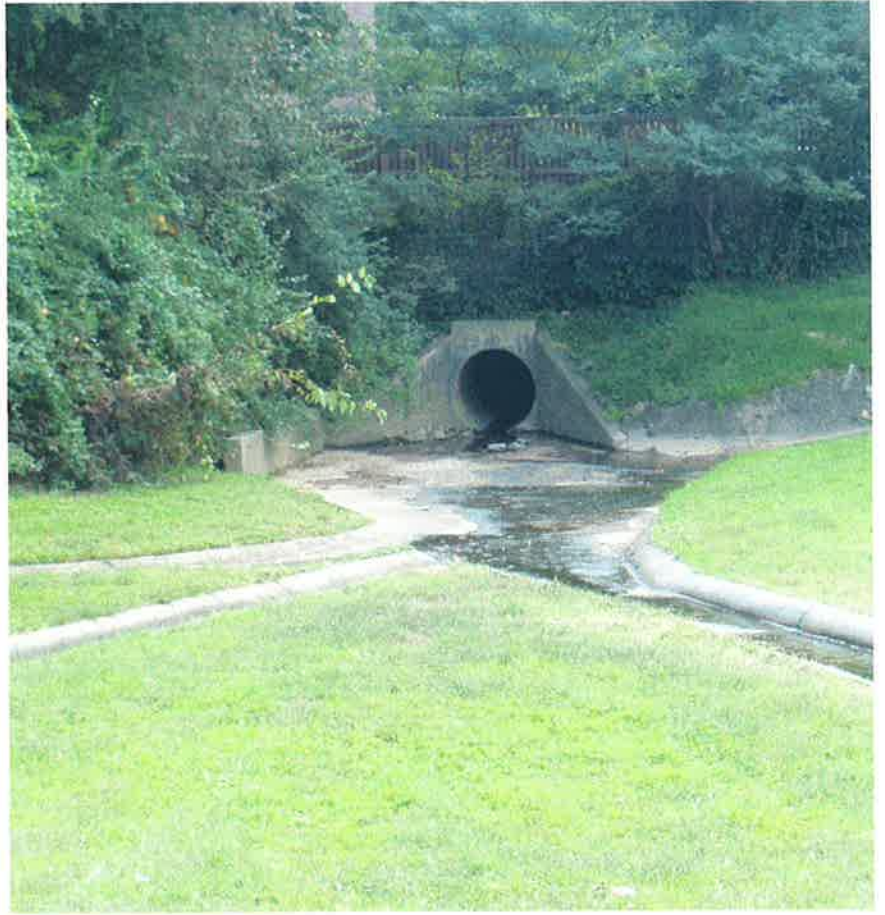
**11**

**Fence around storm water collection area.** We observed a storm water collection area (see photo #11) that is possibly on property owned by the Association. The fence around the facility is in poor condition (see photo #12) and we have included the fence in the *Replacement Reserve Inventory*.

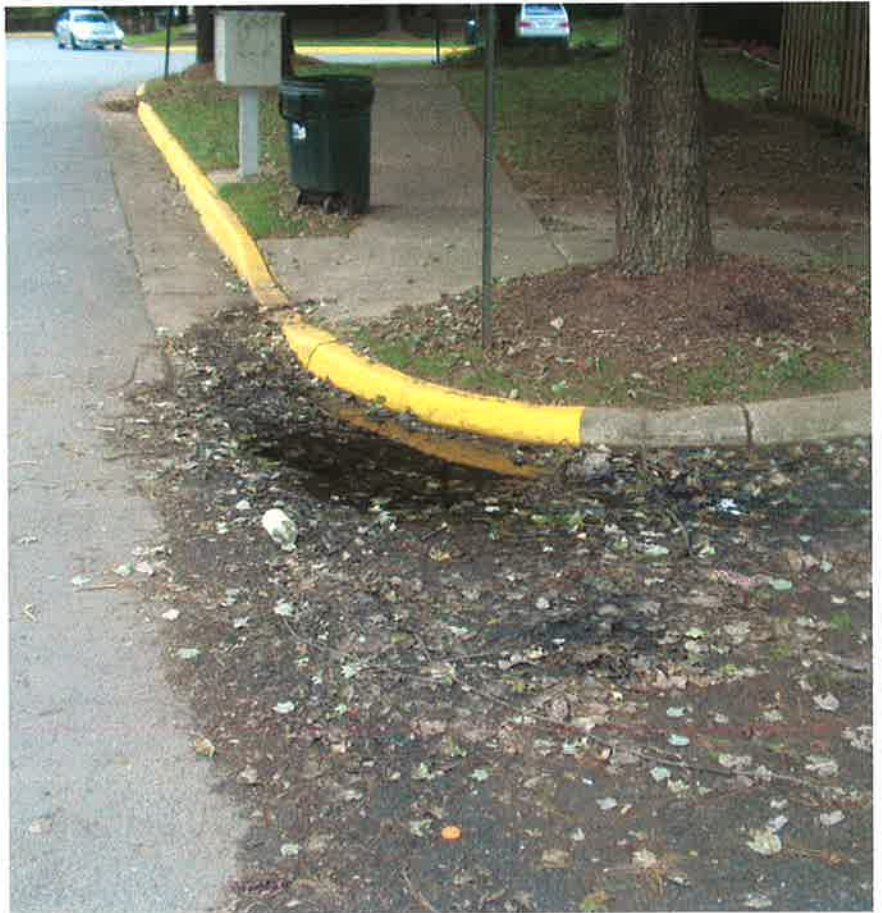
**18**

18. Water ponding in curb, Granite Creek Lane.
19. Depressed utility access, 10317 Granite Creek Lane.
20. Damaged streetlight, 10309 Granite Creek Lane.
21. Street signs need paint.
22. Water is ponding on sidewalks, 10350 Granite Creek Lane. Also note displacement of sidewalk segments.
23. Wood bench slats are in poor condition.
24. General view of tot lot equipment.
25. Wood bench slats are in poor condition.
26. Tot lot equipment is missing components.
27. Tot lot border is in poor condition.
28. Displaced sidewalk segment.
29. Electrical service is in poor condition.
30. Typical mailbox. Note large open crack in asphalt pavement.
31. Typical asphalt pavement damaged by oil/gasoline.
32. Typical residential unit.
