Replacement Reserve Study
FLINT HILL MANOR

FLINT HILL MANOR

Oakton, Virginia

April 10, 2014

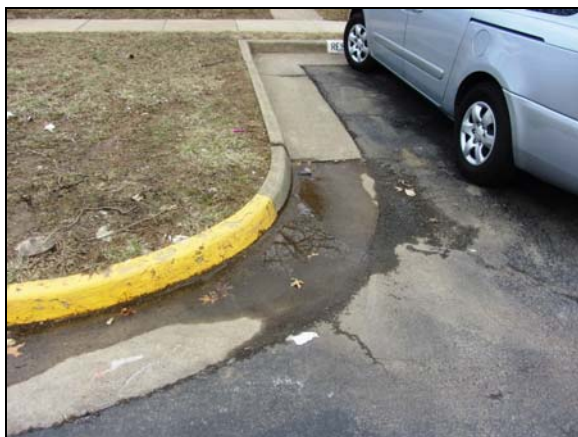
Photo #5. Typical depressed pavement and concrete curb & gutter may indicate damage to base materials and bearing soils beneath the asphalt pavement.

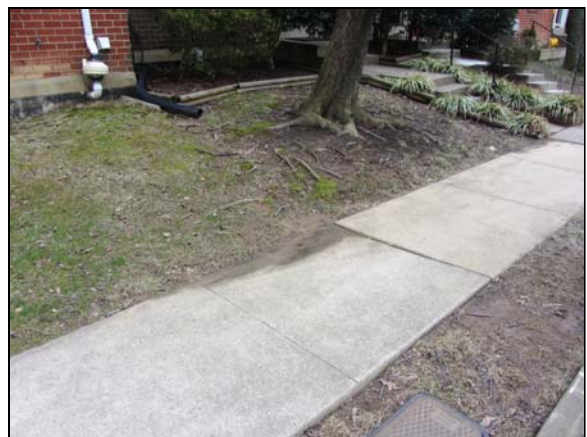
Photo #6. Displaced sidewalk and defective grading impounds water and silt on the concrete pavement, Granite Creek Lane.

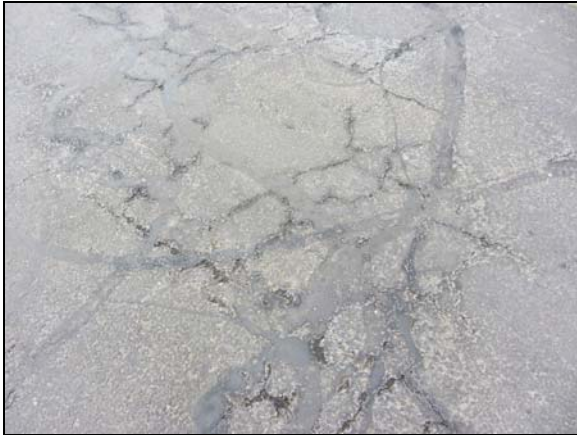
Photo #7. Typical alligatored asphalt pavement, Granite Creek Lane.

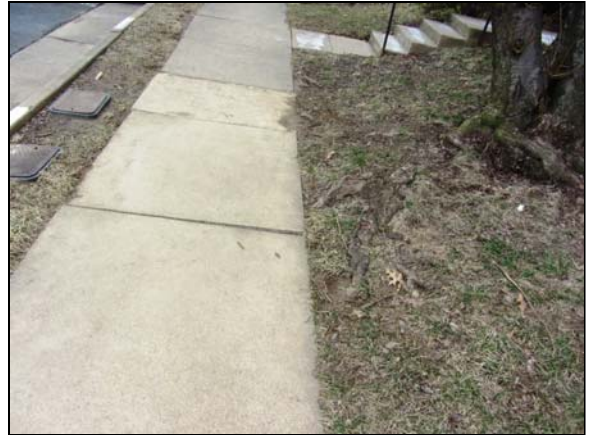
Photo #8. Defective grading between sidewalk and curb & gutter impounds water. Note displaced sidewalk, Granite Creek Lane.

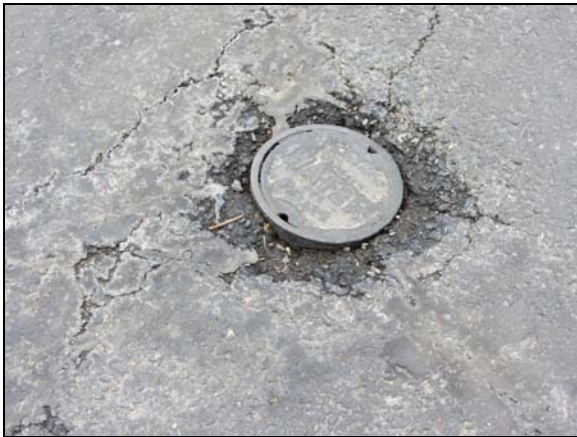
Photo #9. Failed pavement adjacent to utility access point, Granite Creek Lane

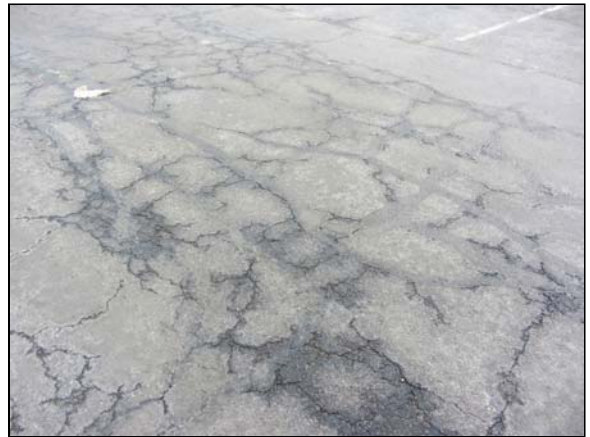
Photo #10. Severely alligatored asphalt pavement, Granite Creek Lane.

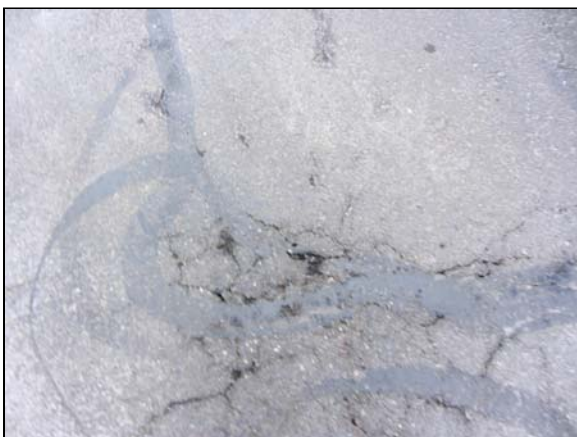
Photo #11. Crack sealing of alligatored pavement, typical.

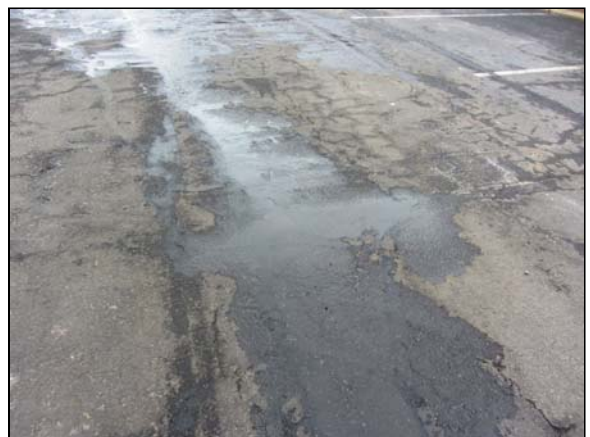
Photo #12. Standing water on asphalt pavement, Granite Creek Lane.

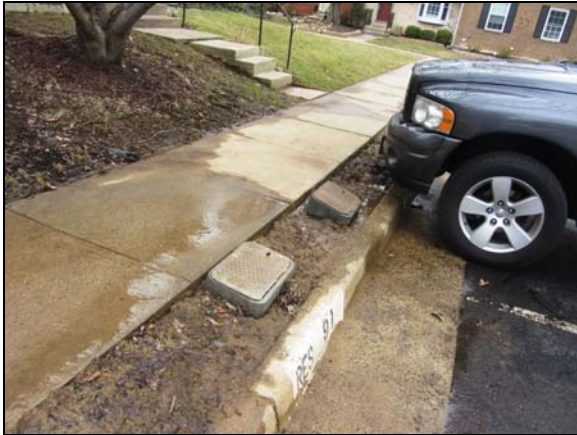
Photo #13. Defective grading between sidewalk and curb & gutter, Granite Creek Lane.

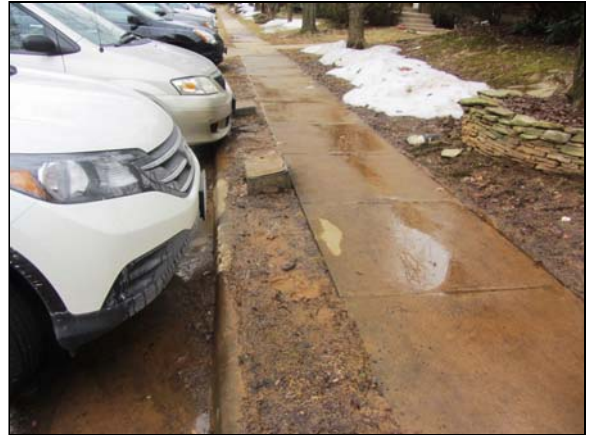
Photo #14. Improperly installed utility access points are potential trip hazards and may indicate that water services are not installed at the proper depth.

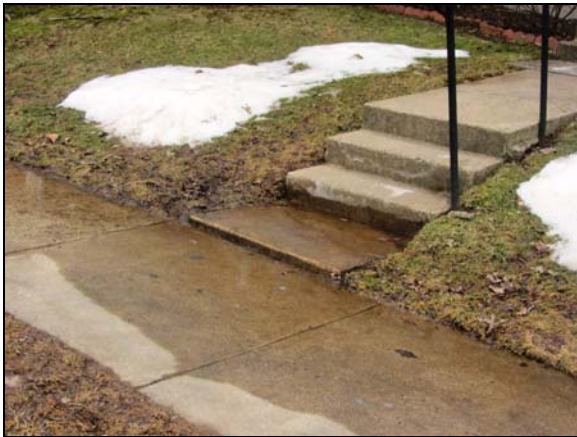
Photo #15. Height differences between sidewalks and lead walks are assumed to be the responsibility of the individual unit owners.

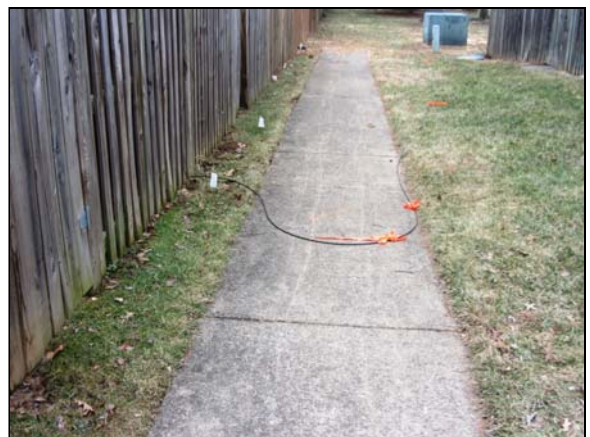
Photo #18. Utility companies have loose-laid wiring on sidewalk, Granite Creek Lane.

- **Utilities.** Contact utility companies and request that they remove all loose-laid cables. See Supplemental Photographs #18.

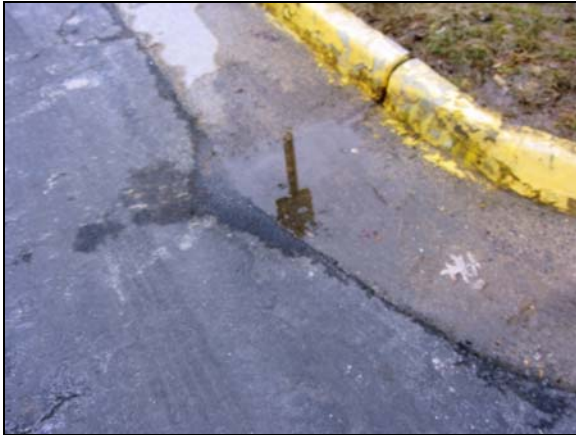
Photo #19. Typical depressed pavement and concrete curb & gutter may indicate damage to base materials and bearing soils beneath the asphalt pavement.

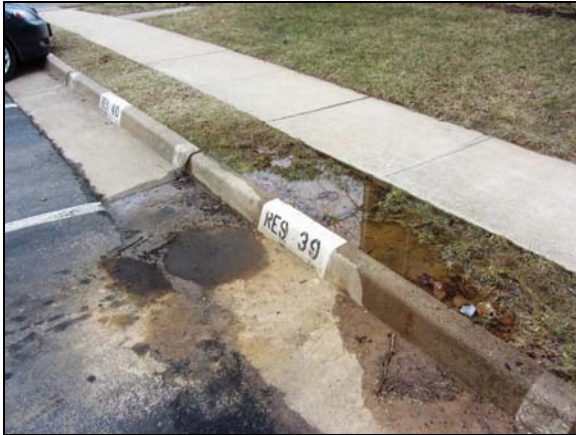
Photo #25. Defective grading between sidewalk and curb & gutter, Silverstone Court.

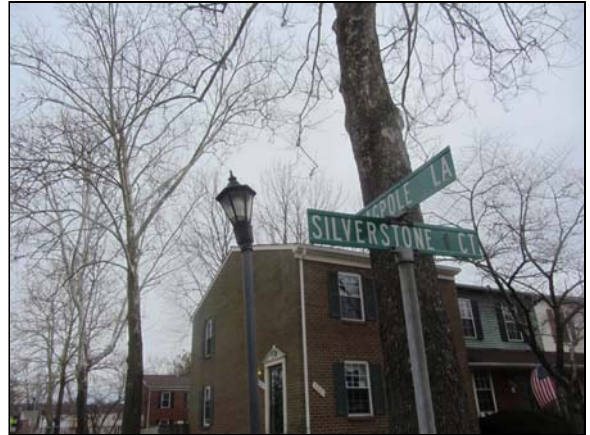
Photo #26. Crooked light fixture at the Silverstone Court entrance to the community.

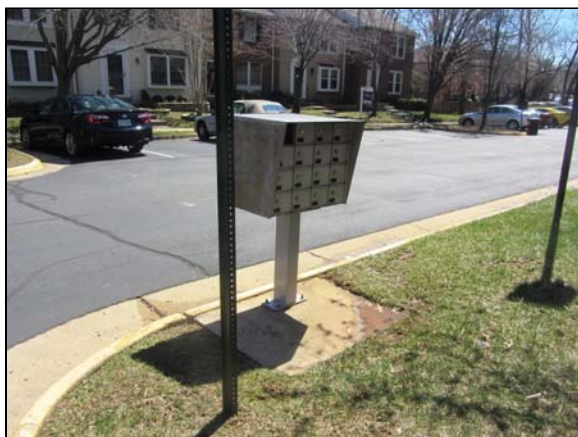
Photo #41. Start of photographs taken on March 31, 2014. Mailbox installation, Graystone Court. Note missing box door.

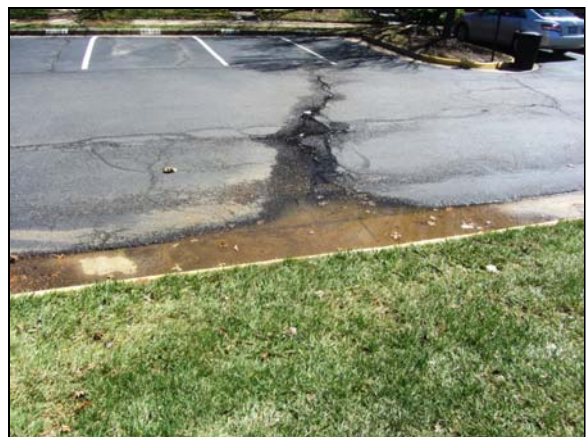
Photo #42. Typical depressed pavement and concrete curb & gutter may indicate damage to base materials and bearing soils beneath the asphalt pavement.

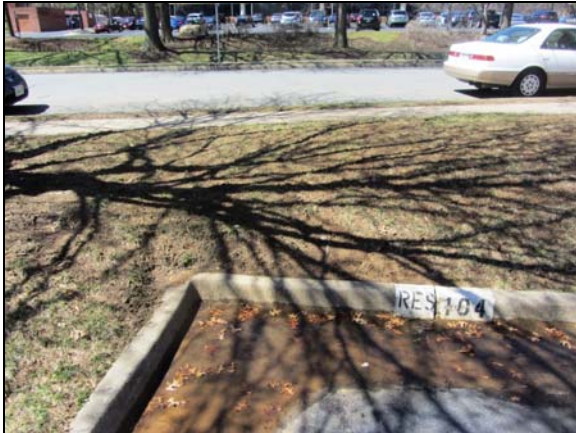
Photo #43. Typical depressed pavement and concrete curb & gutter may indicate damage to base materials and bearing soils beneath the asphalt pavement.

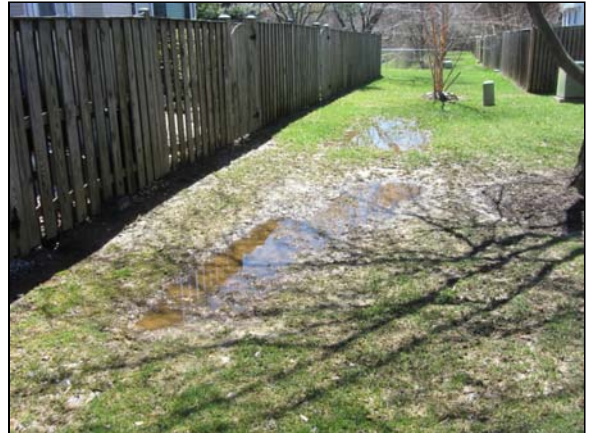
Photo #44. Standing water in open space between Graystone Court and Silverstone Court.

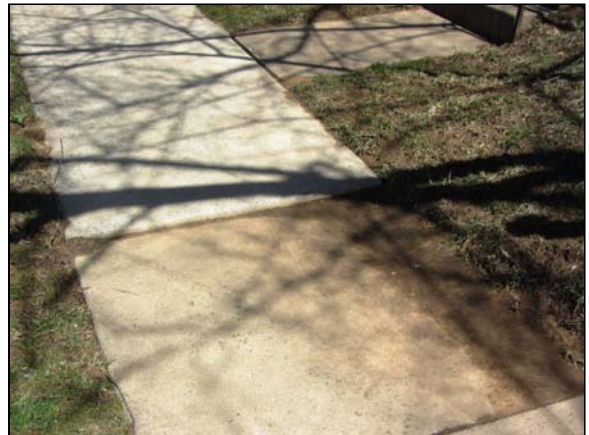
Photo #46. Defective grading and displaced sidewalk segments impound water and silt on the pavement, typical.

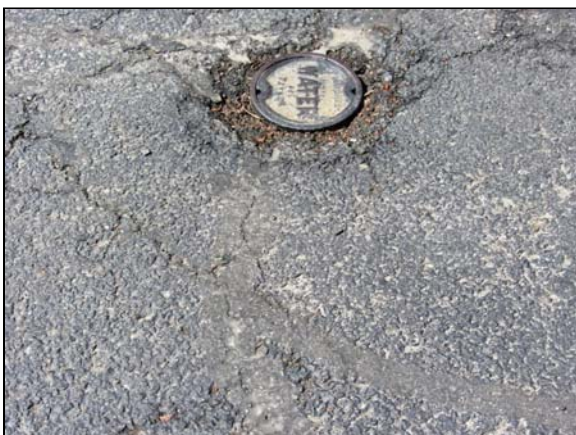
Photo #47. Typical failed pavement at utility access point.

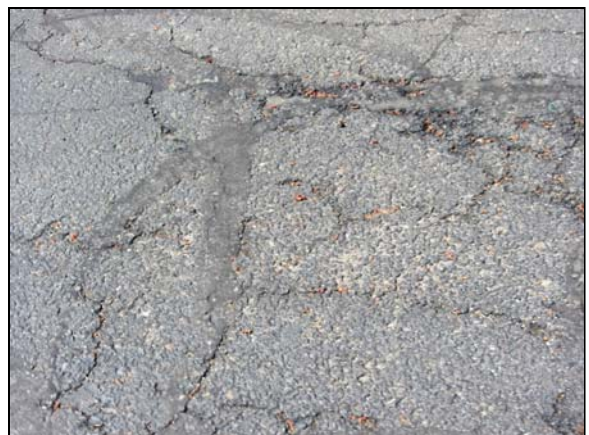
Photo #48. Typical alligatored asphalt pavement.

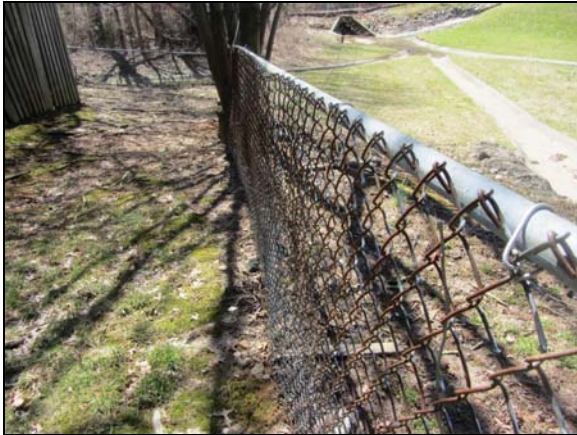
Photo #49. Rusty fence at stormwater impound facility.

- Make minor repairs/replacements to the fence at the stormwater collection/impound along the south property boundary in the southwest corner of the community. See Supplemental Photographs #31, 33, 49.

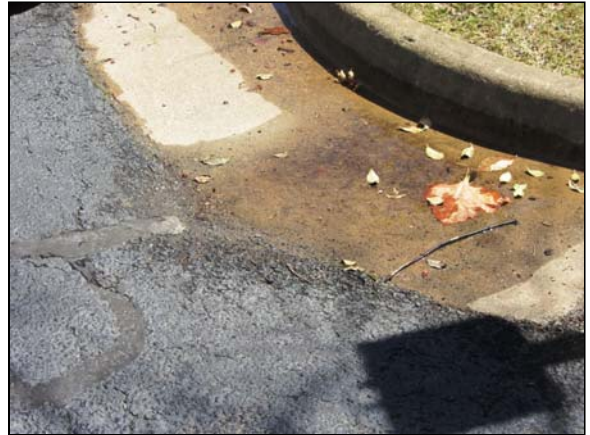
Photo #50. Typical depressed pavement and concrete curb & gutter may indicate damage to base materials and bearing soils beneath the asphalt pavement.

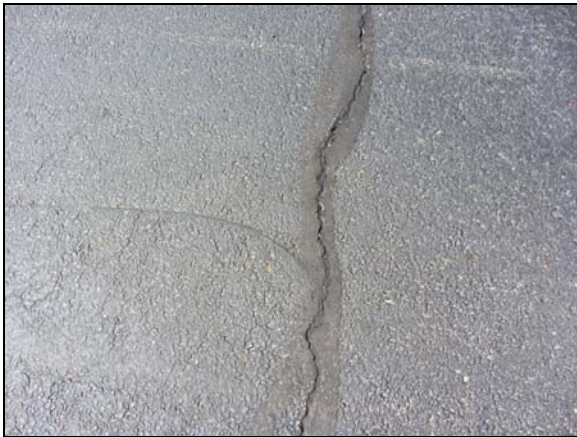
Photo #51. Typical open crack in asphalt pavement. Note failed crack seal.

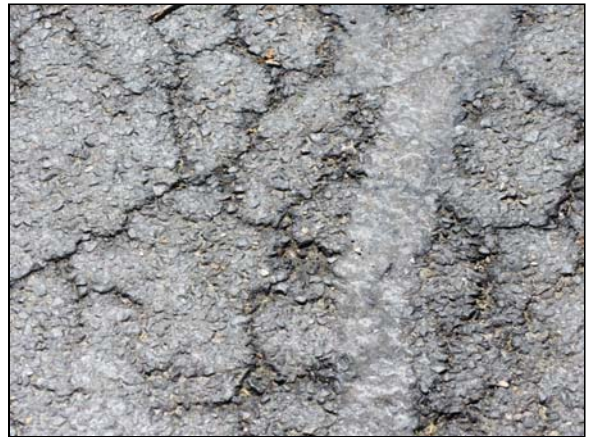
Photo #52. Typical deteriorated and alligatored asphalt pavement.

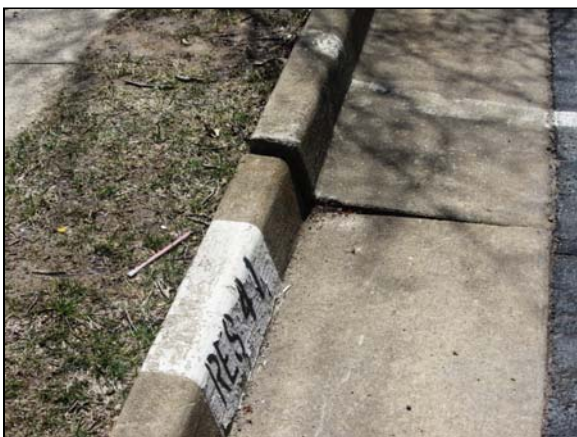
Photo #53. Displaced curb & gutter, typical.

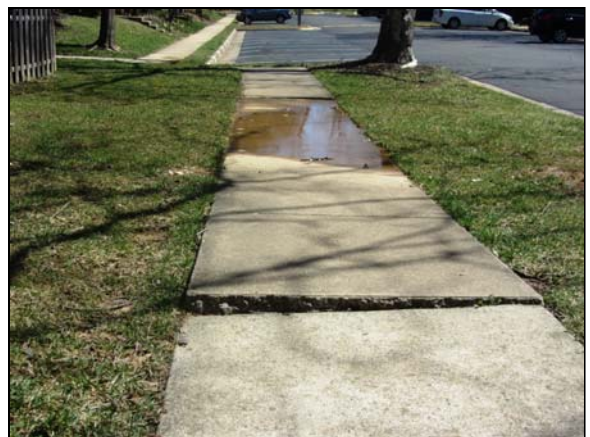
Photo #54. Displaced sidewalk is a trip hazard, typical.

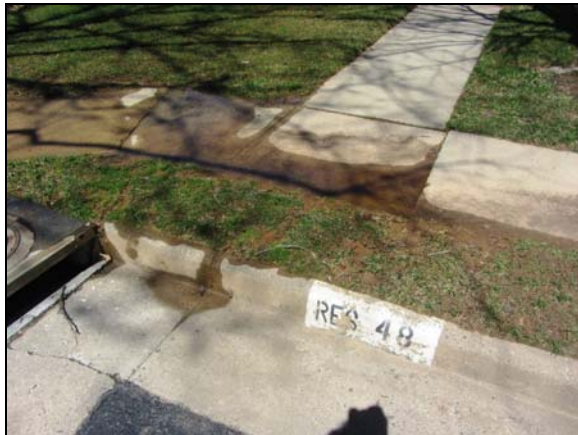
Photo #55. Defective grading and displaced sidewalk segments impound water and silt on the pavement, typical.

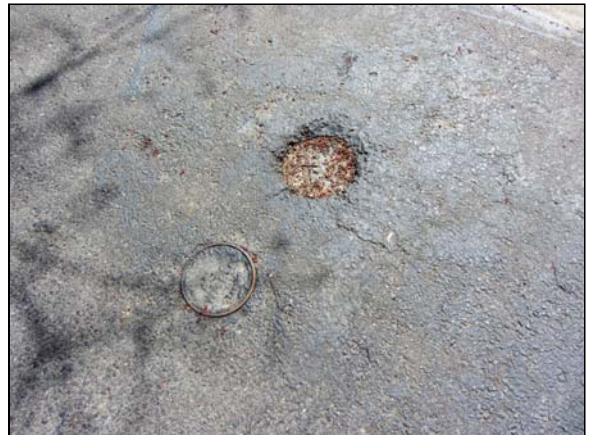
Photo #56. Defective utility access point impounds water, Granite Creek Lane.
