RSTUDY+  
REPLACEMENT RESERVE STUDY  
**FLINT HILL MANOR**  
Homeowners Association

Oakton, Virginia

**November 2003**

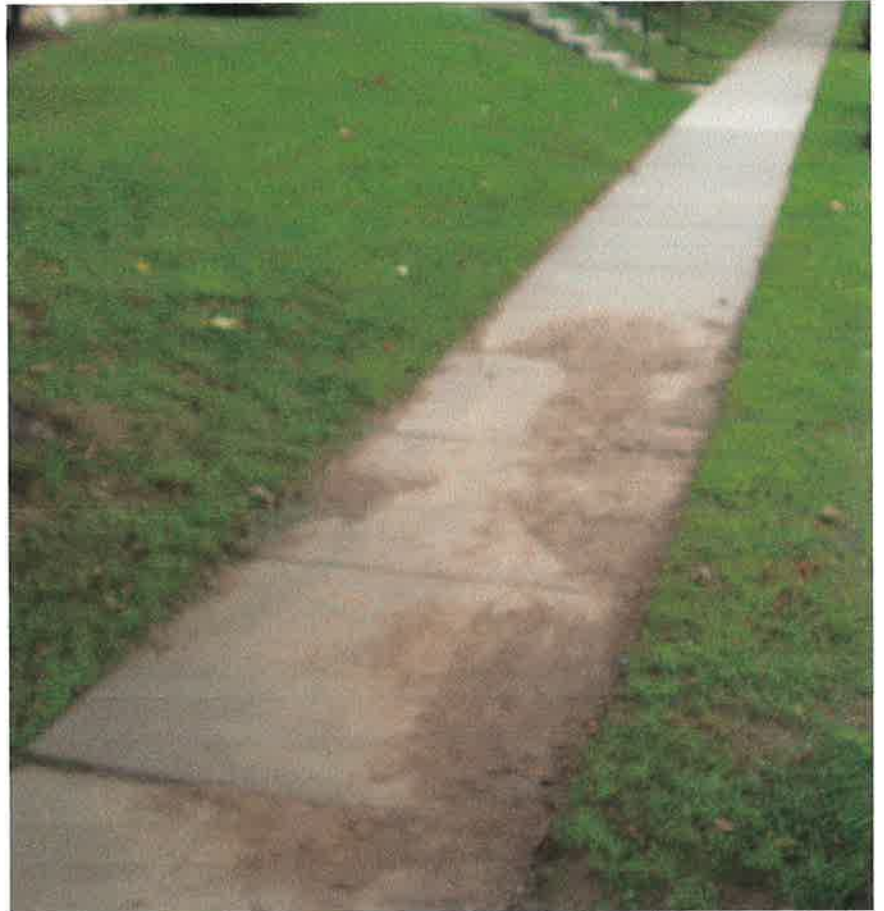
**22**

18. Water ponding in curb, Granite Creek Lane.
19. Depressed utility access, 10317 Granite Creek Lane.
20. Damaged streetlight, 10309 Granite Creek Lane.
21. Street signs need paint.
22. Water is ponding on sidewalks, 10350 Granite Creek Lane. Also note displacement of sidewalk segments.
23. Wood bench slats are in poor condition.
24. General view of tot lot equipment.
25. Wood bench slats are in poor condition.
26. Tot lot equipment is missing components.
27. Tot lot border is in poor condition.
28. Displaced sidewalk segment.
29. Electrical service is in poor condition.
30. Typical mailbox. Note large open crack in asphalt pavement.
31. Typical asphalt pavement damaged by oil/gasoline.
32. Typical residential unit.
