Replacement Reserve Study
FLINT HILL MANOR

FLINT HILL MANOR

Oakton, Virginia

April 10, 2014

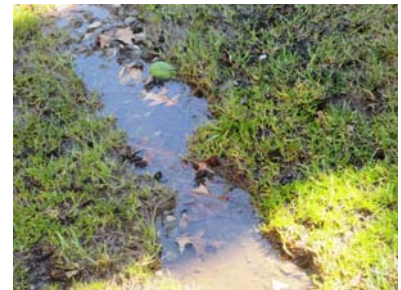
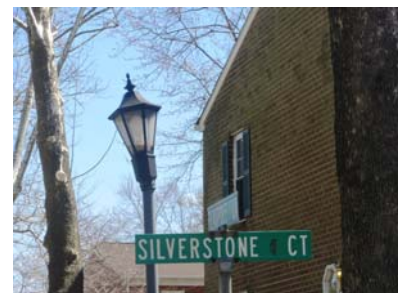
- Correction of defective base materials and bearing soils beneath the asphalt pavement that are a consequence of the pavement having been kept in service beyond the end of its normal economic life.
- The correction of various site grading and drainage issues throughout the community.
- Maintenance and repair of the streetlights and associated electrical services.

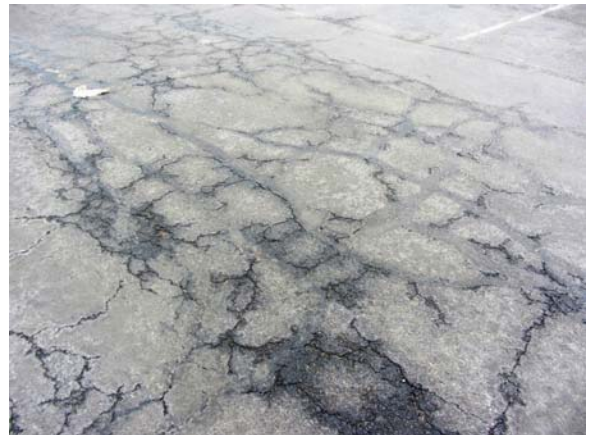
Asphalt pavement - general. The *Replacement Reserve Inventory* identifies approximately 49,147 square feet of asphalt pavement throughout the community that is the responsibility of the Association. No information about the dates of installation or the specifications that were used to install the pavement was provided for our review. The asphalt pavement is generally at or beyond the end of its normal economic life. We observed areas where defects in the asphalt pavement are allowing large amounts of water to penetrate through the pavement, causing damage and deterioration of the load carrying capabilities of the base materials and bearing soils beneath the pavement. The defects we observed included areas with open cracks, large holes in the pavement, severe alligating, and depressed areas of pavement indicating damage to the base materials and bearing soils beneath the pavement.

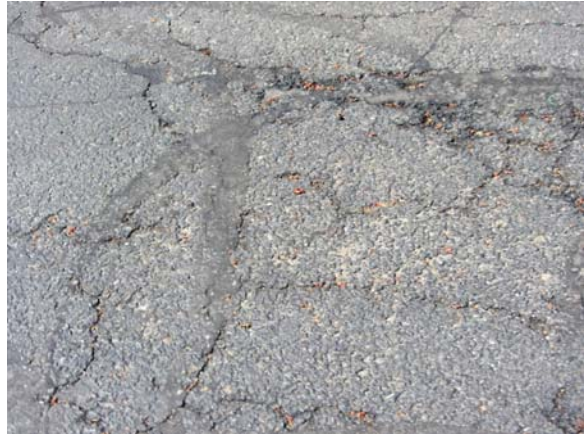
Areas of asphalt pavement with more serious defects, where the asphalt pavement has significant damage and/or deterioration, or where base materials and/or bearing soils beneath the pavement have been damaged, should have defective asphalt pavement, base materials, and bearing soils removed and replaced with materials capable of properly supporting the new pavement.

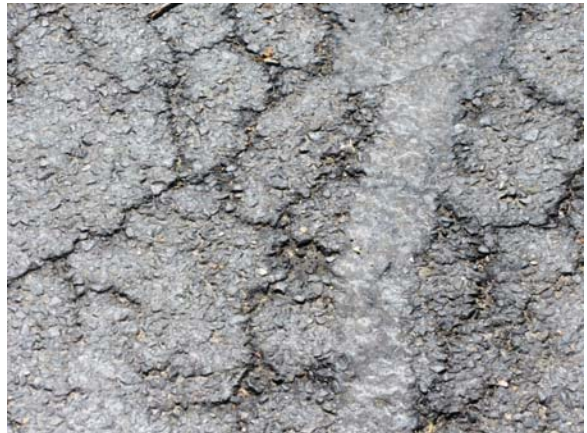
Failure to accomplish proper repairs prior the installation of a new asphalt top coat will result in the new pavement having a substantially reduced economic life as the old failures rapidly print through to the new asphalt. An asphalt pavement overlay, installed over defective pavement, frequently begins failing almost immediately and will generally be at complete failure in two to five years.

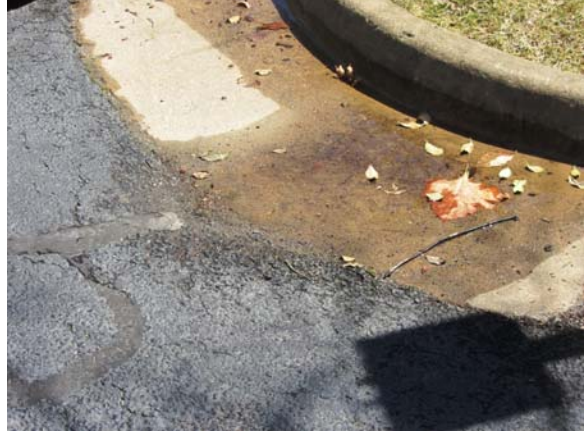
Multiple segments of concrete curb & gutter are damaged and/or displaced. These defective segments of curb & gutter will prevent proper grading of the new asphalt pavement and/or allow water to penetrate into the bearing soils beneath the curb & gutter segments and adjacent asphalt pavement. These curb & gutter segments should be replaced before, or in conjunction with, the project to replace the asphalt pavement, to establish a proper grade and insure that all water is properly directed to the storm water system.

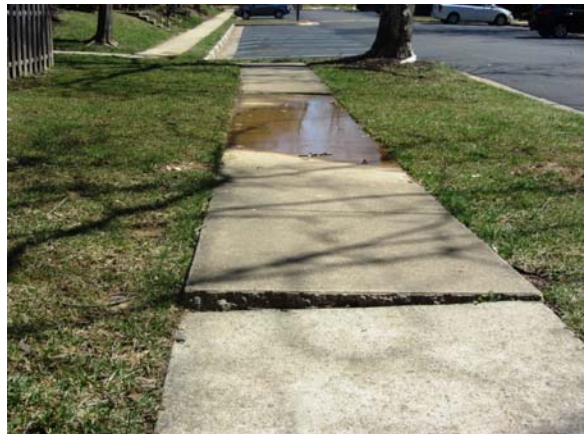
Concrete components. The *Replacement Reserve Inventory* identifies approximately 10,840 square feet of concrete pavement (sidewalks) and 3,170 feet of concrete curb & gutter throughout the community that is the responsibility of the Association. There are extensive defects in these components including components that are severely deteriorated, damaged, and displaced. Some of these defects are trip hazards and we recommend that the defective components be replaced as soon as possible to protect the residents from potential injury and the Association from potential liability for those injuries.

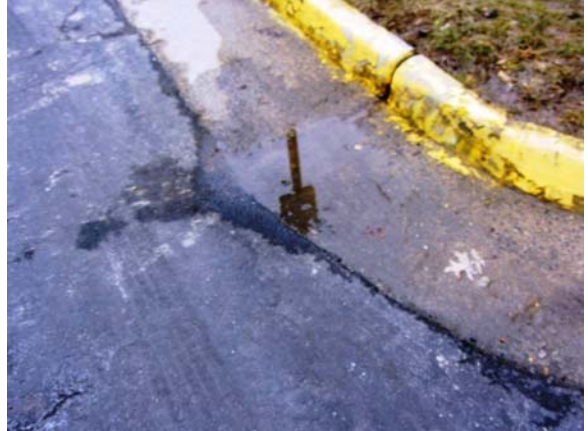
As noted above, multiple segments of curb & gutter will need to be replaced prior to, or in conjunction with, the asphalt replacement project to insure that the new asphalt pavement can be properly graded to direct water to the storm water system.

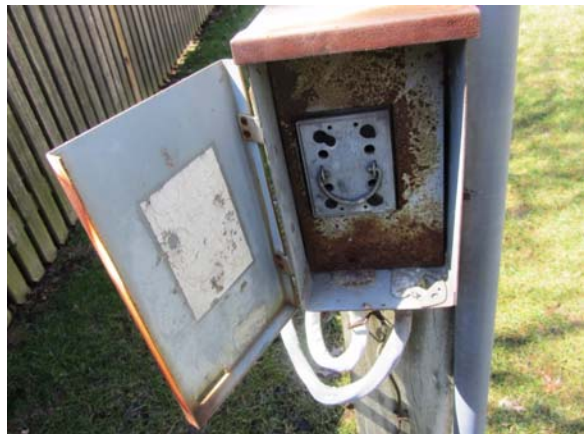
Streetlights. The Association is responsible for a network of 10 streetlights and associated electrical services and wiring. The Association has made multiple maintenance, repair, and replacement operations to the system. More is needed and in the *List of Recommended Repairs* we have included a project to address defects in the system. We have assumed that a comprehensive maintenance and repair project at the present time will allow the system to be kept in service until 2025 when we have scheduled a comprehensive replacement in the *Replacement Reserve Inventory*.

We further recommend that at replacement, the Association negotiate with the local power company to assume responsibility for the entire system. The new system will need to be installed to their standard and there is a monthly fee.

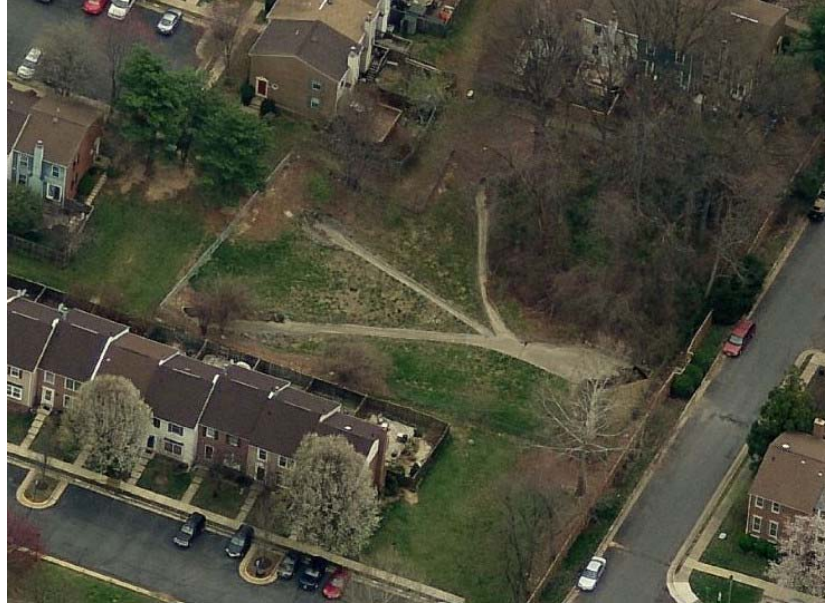
The community is served by an extensive stormwater system that includes inlets, outlets, subsurface piping, trickle ditches, and a collection/impound area along the south property boundary. We discussed this facility with the Board of Directors in conjunction with the preparation of the November 2003 *Replacement Reserve Study* and they reported that the Association was ONLY responsible for the fence surrounding the collection/impound facility.

The Association has recently replaced a large section of the fence and in the *Replacement Reserve Inventory*, we have assumed the Association will inspect the fence in 2017 and make any needed replacements.

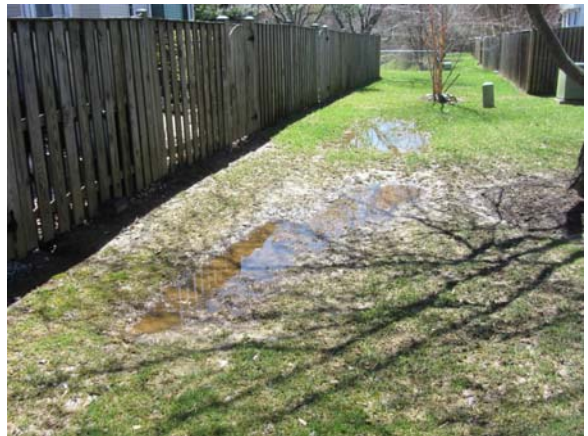
Site grading. The *List of Recommended Repairs* includes extensive site grading defects that need to be corrected if the adjacent common elements are to achieve their normal economic life.

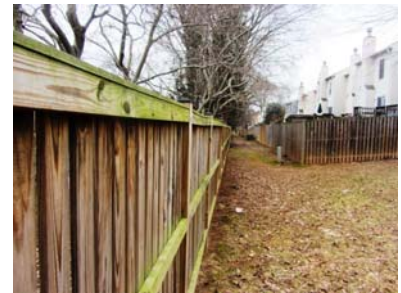
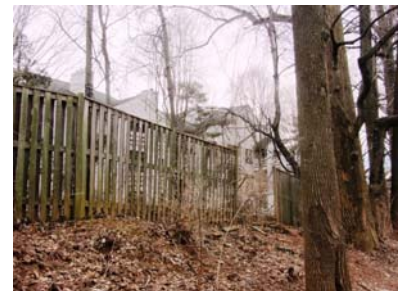
Fences - property lines. A wood stockade fences are installed along the south and east property lines. We have assumed that the fences are the responsibility of the adjacent communities. The fence along the south boundary is generally in good condition. The fence along the east boundary is in poor condition and several sections are damaged. We recommended the Association confirm ownership of both fences.

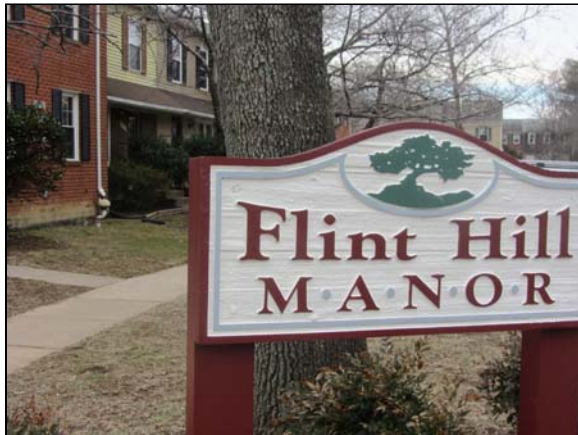
Photo #1. Start of photographs taken on March 11, 2014. Property identification signage at the Granite Creek Lane entrance to the community.

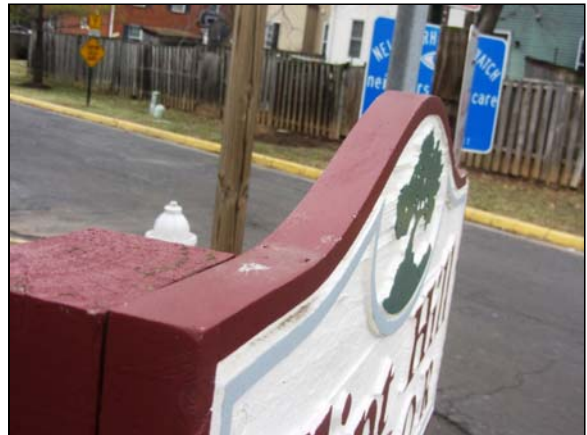
Photo #2. Detailed view of property identification signage.

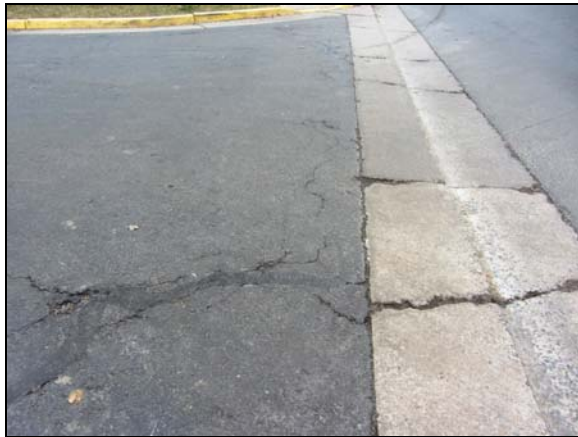
Photo #3. Asphalt pavement and concrete apron at the intersection of Granite Creek Lane and Flagpole Lane.

- Replace the asphalt pavement throughout the community including the roadways and parking areas. The project should include the operations discussed below. See Supplemental Photographs #3, 7, 9, 10, 11, 12, 19, 27, 35, 37, 42, 45, 47, 48, 50, 51, 52, 56.

- Replace the existing asphalt pavement by overlaying with 2 inches of new asphalt. Prior to the installation of the new pavement, mill the existing asphalt pavement to insure that the final grade of the new pavement will not impound water and to eliminate the need to run the asphalt pavement into the curbs.

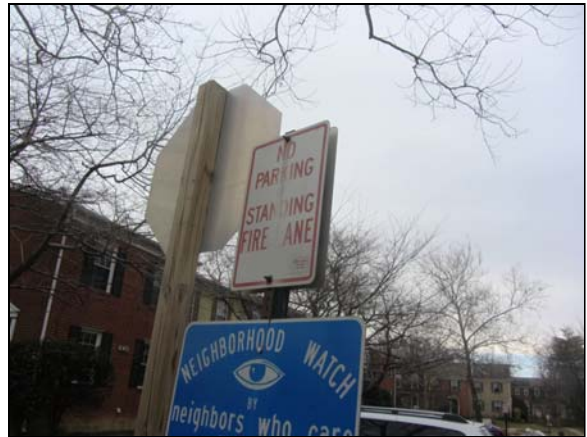
Photo #4. Typical faded signage.

- Restore deteriorated paint finish on signs throughout the community. See Supplemental Photographs #4.

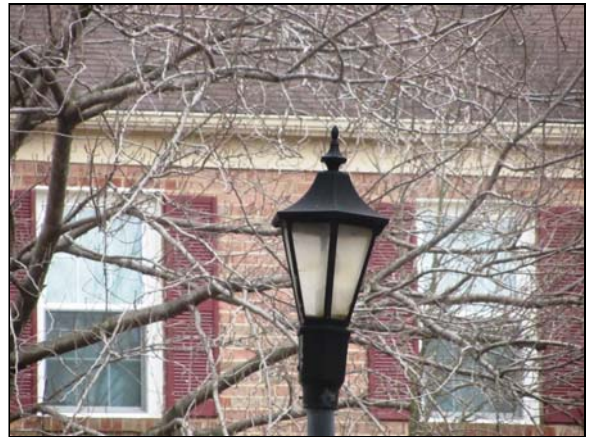
Photo #16. Older (original?) streetlight fixture.

- **Streetlights.** Conduct a minor renovation project to address defects in the streetlights and the electrical services that serve the streetlight to enable the system to be kept in service until 2025. See Supplemental Photographs #16, 17, 20, 26, 39, 60.

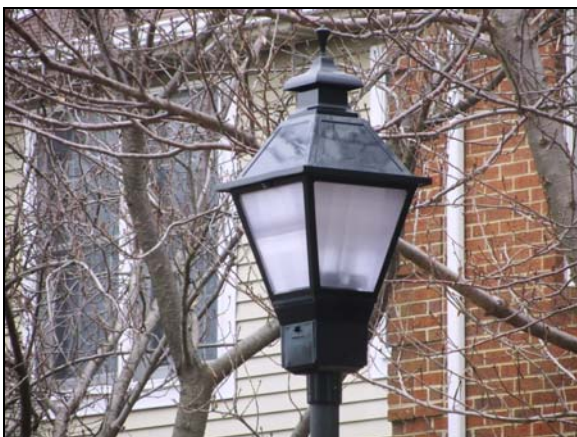
Photo #17. Newer (replacement?) streetlight fixtures.

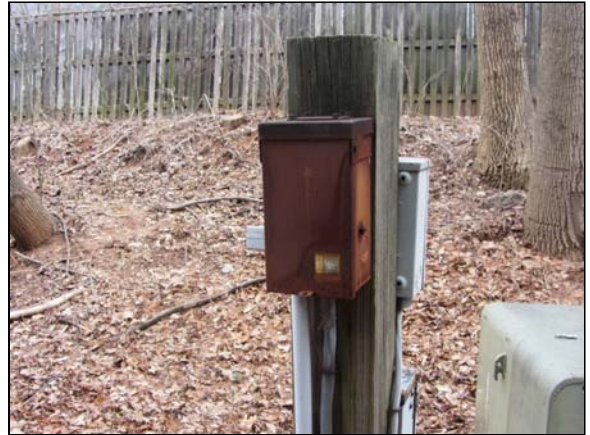
Photo #20. Common electrical service.

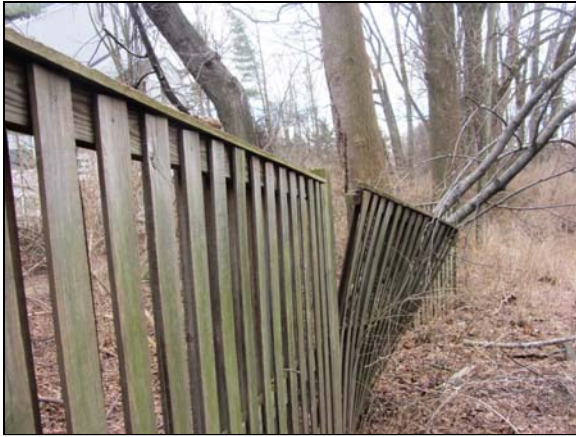
Photo #21. Fence installed along the east property boundary.

- Request those responsible for the fence installed along the east property boundary to remove the fence or to make needed repairs/replacements. See Supplemental Photographs #21.
- Request those responsible for the stormwater management facility to properly identify the facility. See Supplemental Photographs #59.
- Repair damaged mailbox. See Supplemental Photographs #41.

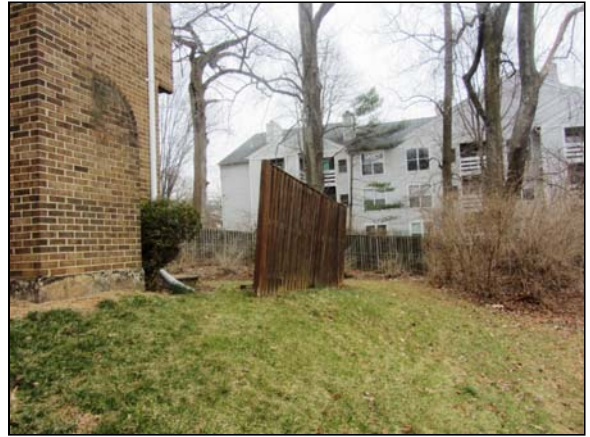
Photo #22. Limited wood fence installations at end unit, Granite Creek Lane

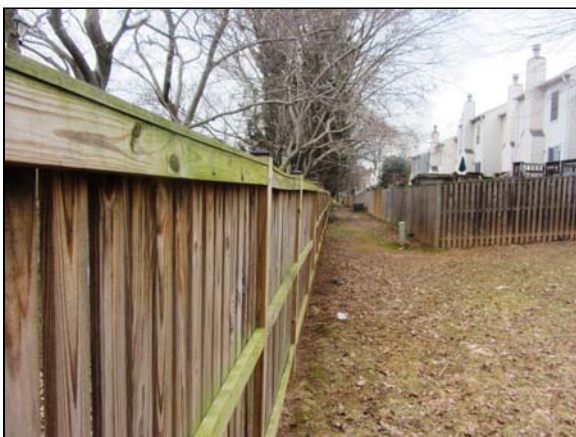
Photo #23. Wood stockade fence installed along the south property boundary.

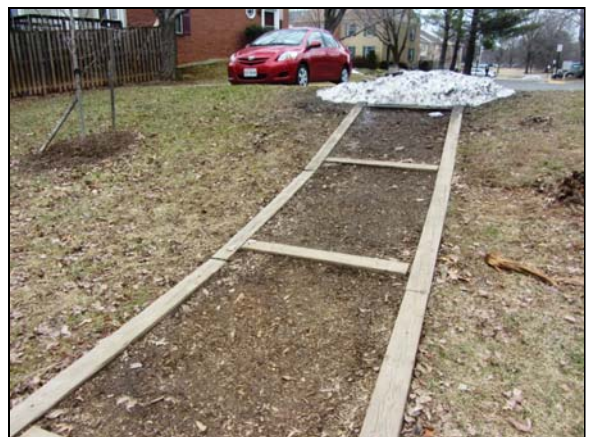
Photo #24. Timber wall connects sidewalk common sidewalks to the adjacent community.

- Trail. Install a proper concrete sidewalk to replace the mulch and timber trail at the southeast corner of the community. See Supplemental Photographs #24.

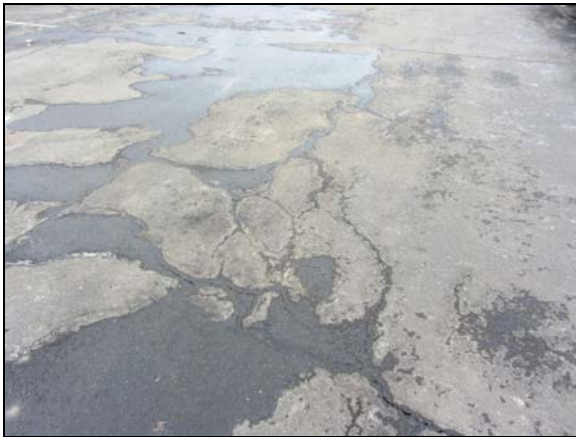
Photo #27. Alligatored asphalt pavement, Silverstone Court.

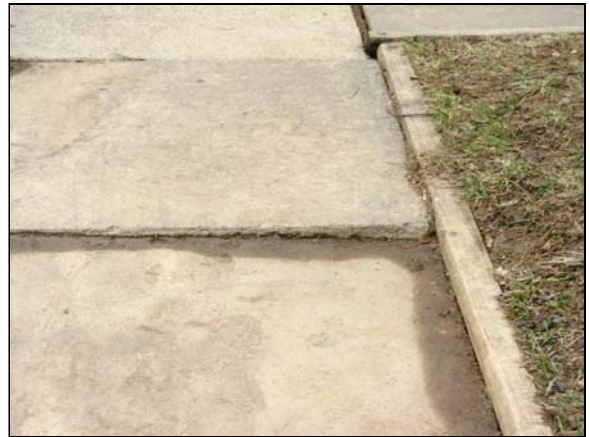
Photo #28. Displaced sidewalk, Silverstone Court.

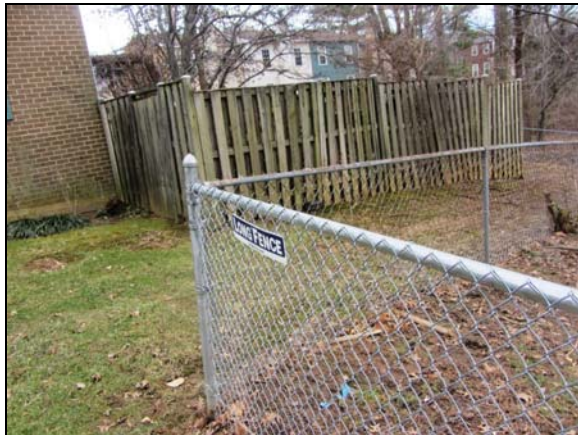
Photo #31. Fence around the stormwater impound facility. Note that fence in foreground has been recently installed and other fence sections are much older.

- Make minor repairs/replacements to the fence at the stormwater collection/impound along the south property boundary in the southwest corner of the community. See Supplemental Photographs #31, 33, 49.

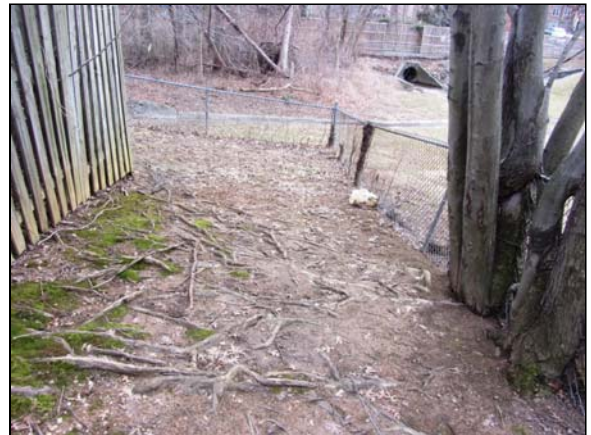
Photo #32. Typical common property without proper ground cover.

- **Grade adjacent to concrete pavement to prevent water, silt, and debris from being impounded on the components, a potential trip hazards. See Supplemental Photographs #6, 46, 55**
- **Properly set utility access points installed between the sidewalks and curb & gutter where the installations are potential trip hazards. See Supplemental Photographs #13, 14**
- **Grade between sidewalk and curb & gutter to eliminate ponding water and the consequential damage to the base and bearing materials under the adjacent components. See Supplemental Photographs #8, 25**
- **Remove or properly install pavers installed on property owned by the Association. See Supplemental Photographs #29.**
- **Correct defective grading that impounds water on property owned by the Association. Establish proper ground cover on property owned by the Association. See Supplemental Photographs #32, 44.**

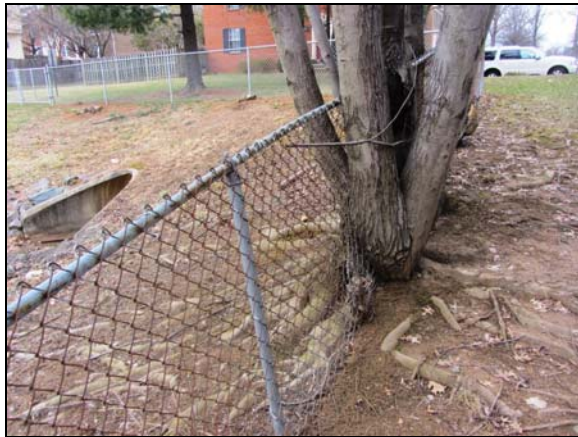
Photo #33. Stormwater fence is captured in the tree.

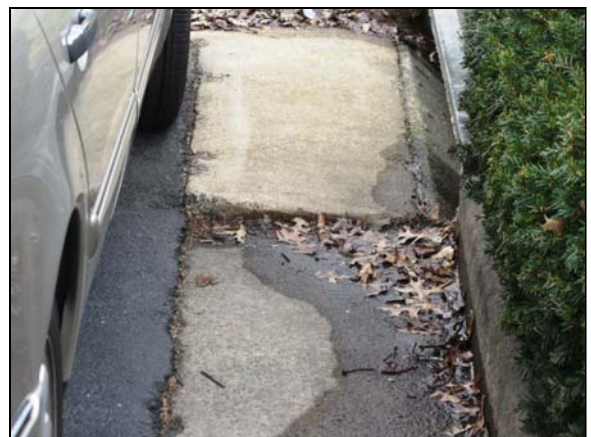
Photo #36. Displaced curb & gutter at stormwater inlet, Graystone Court.

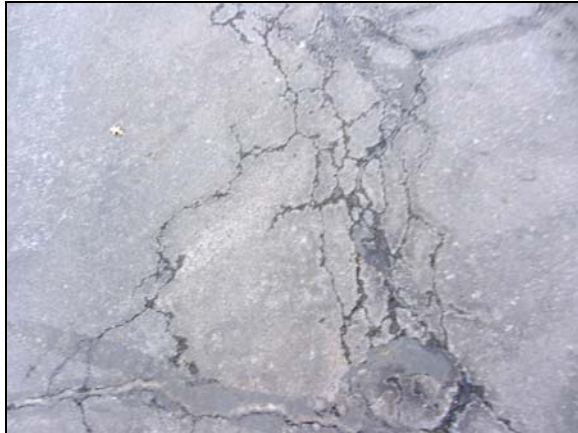
Photo #37. Alligatored asphalt pavement, Graystone Court.

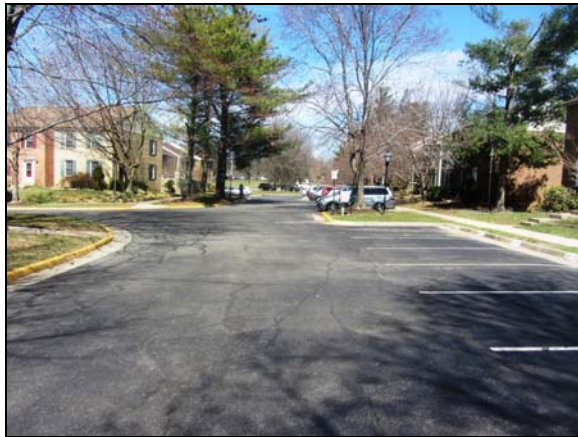
Photo #56. Defective utility access point impounds water, Granite Creek Lane.

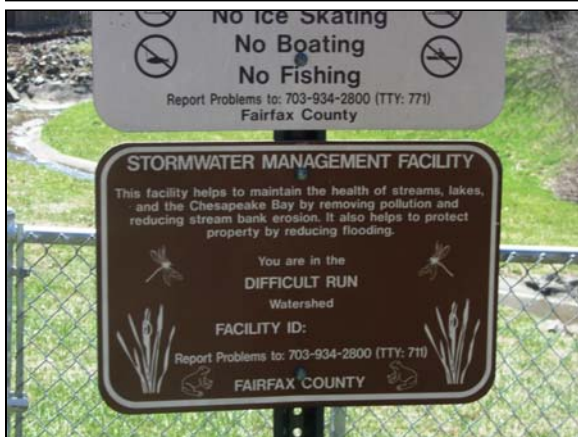
Photo #59. Stormwater impound does not have a "Facility ID".
